City of Gering Pool Study

Public Input Meeting
May 12, 2025

Miller & Associates
CONSULTING ENGINEERS, P.C.

Swimming Pool Study
2024 - 2025
Gering, Nebraska

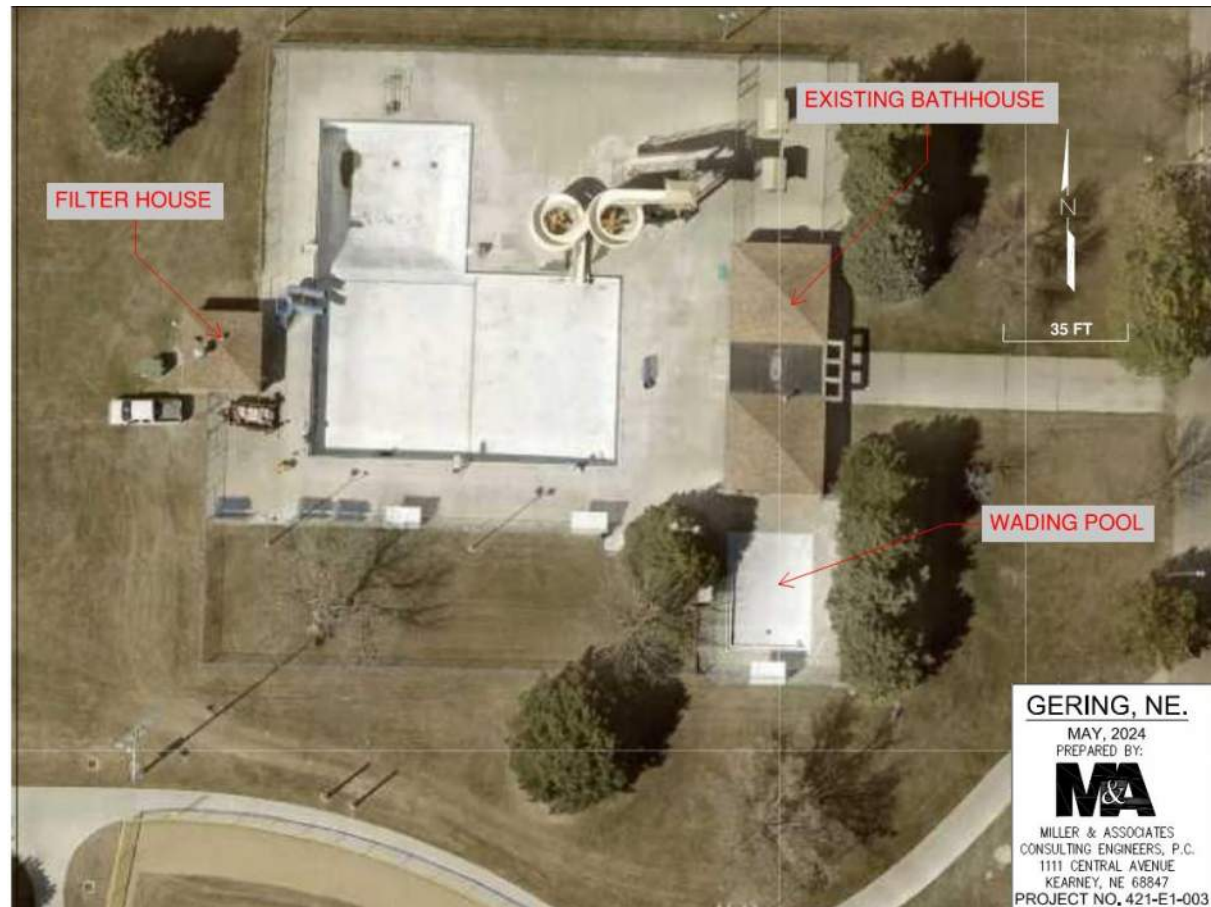
Option 2:

Rehab Bathhouse, New Zero-Entry Wading Pool, & Pool Improvements

Rehab the Bathhouse
-

New Zero-Entry Wading Pool
-

Rehab Swimming Pool
-

Replace Pool Deck & Deck Equipment
-

Replace the DE Filter & Pump
-

Preliminary Engineers Opinion of Probable Project Costs: **\$ 2,980,300**

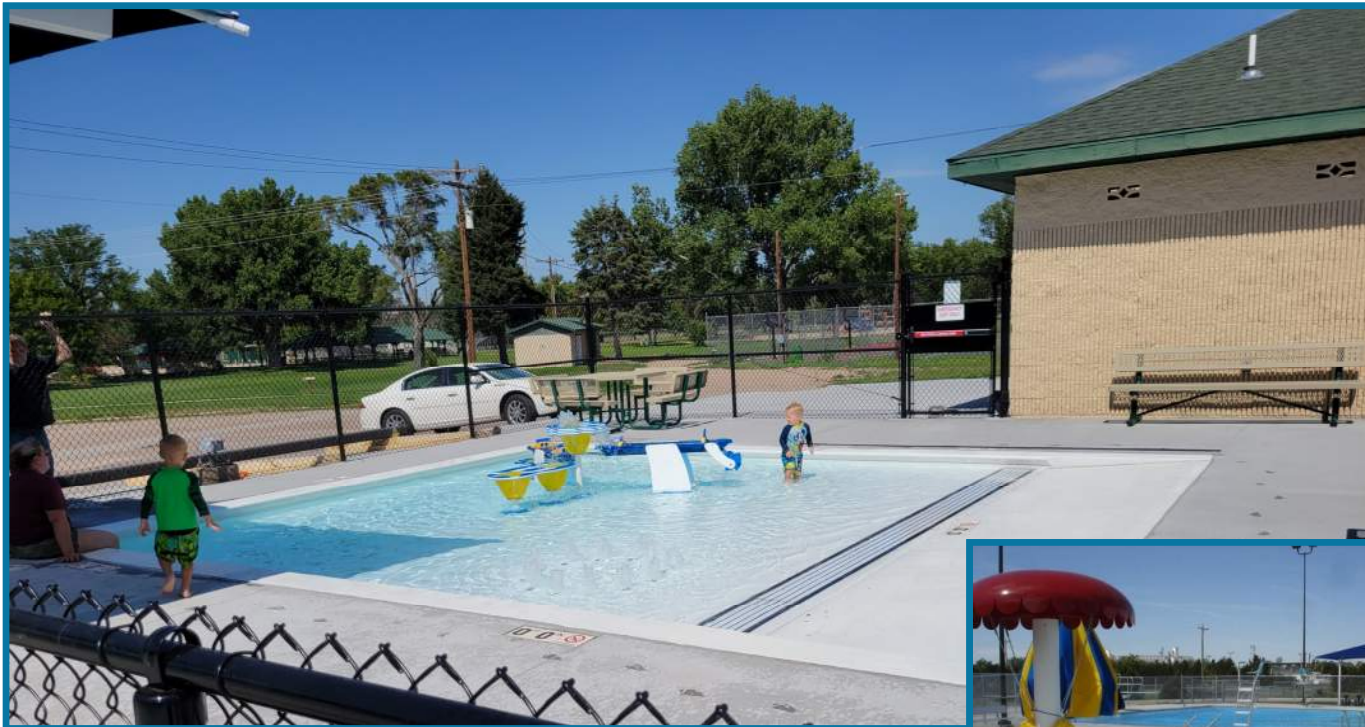
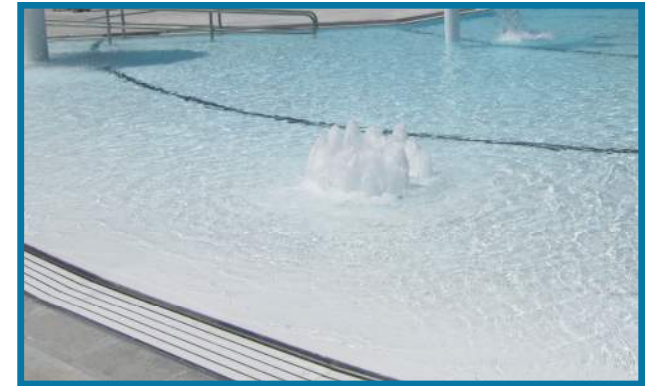
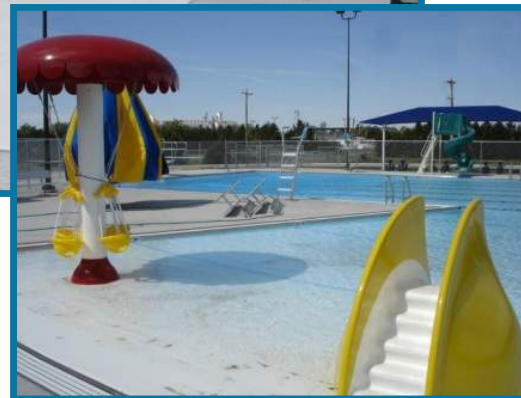
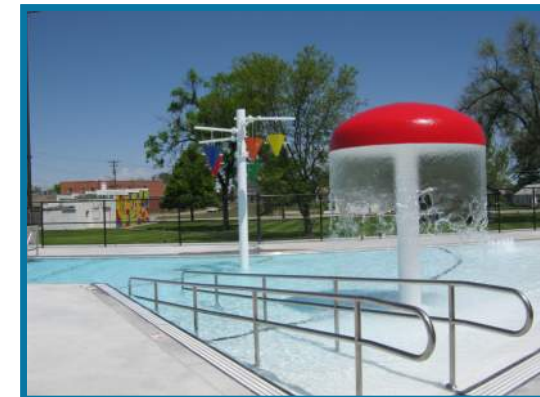
Option 2

New Wading Pool Amenities

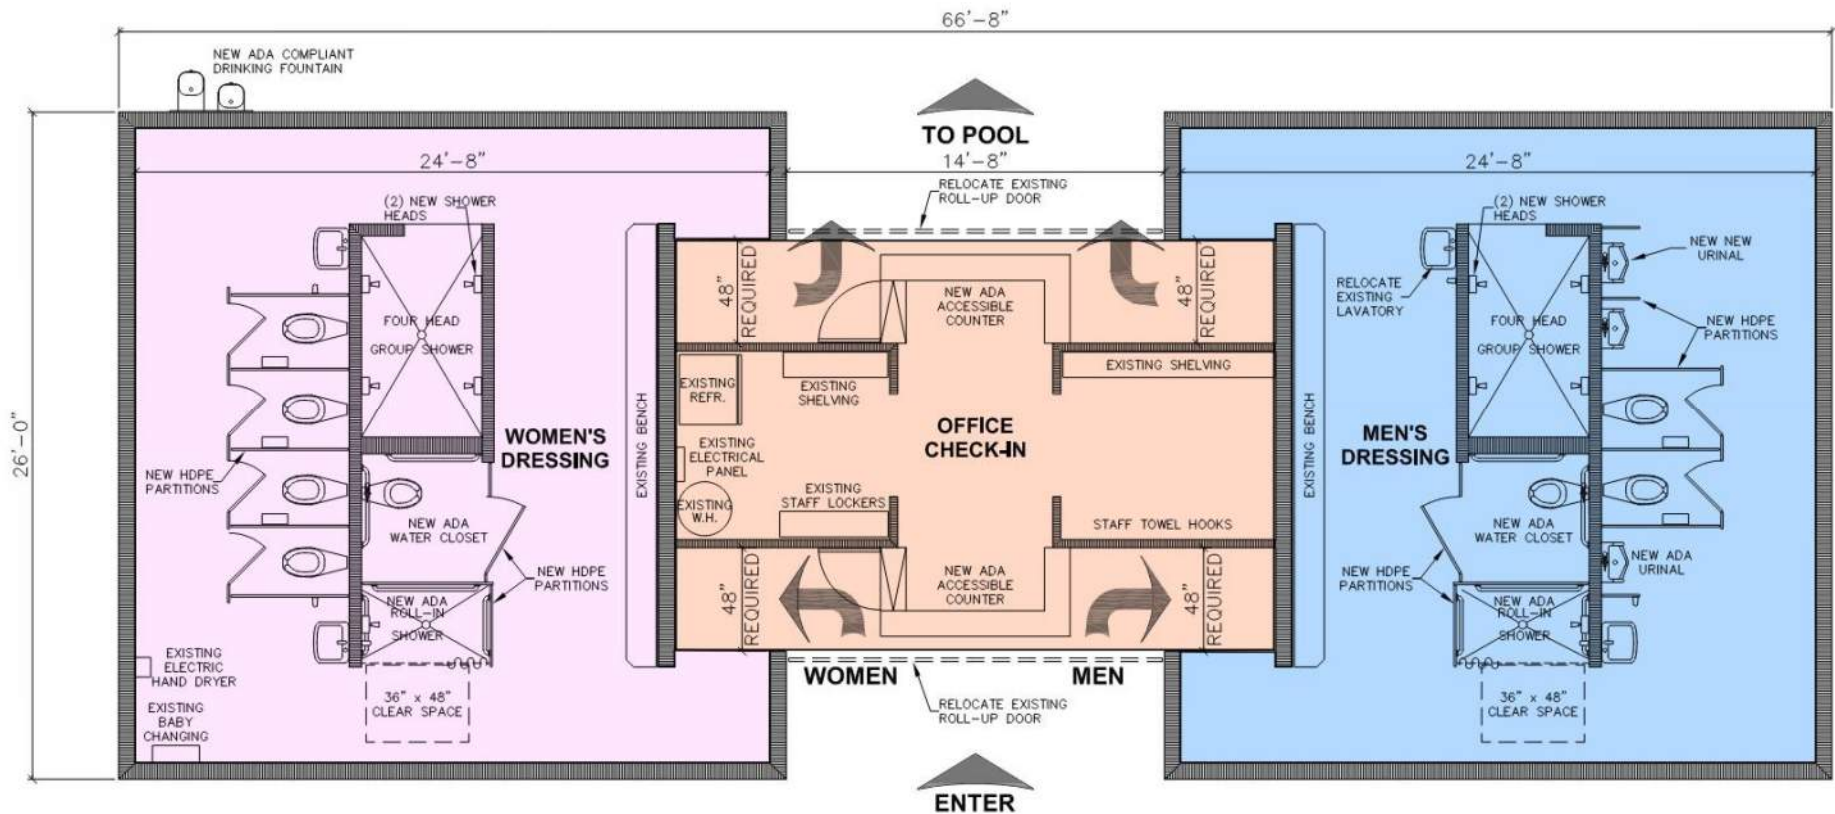
Option 2:

Rehabilitate Bathhouse, New Zero-Entry Wading Pool, and Pool Improvements*

****Will address all deficiencies except for the required recirculation rate.***

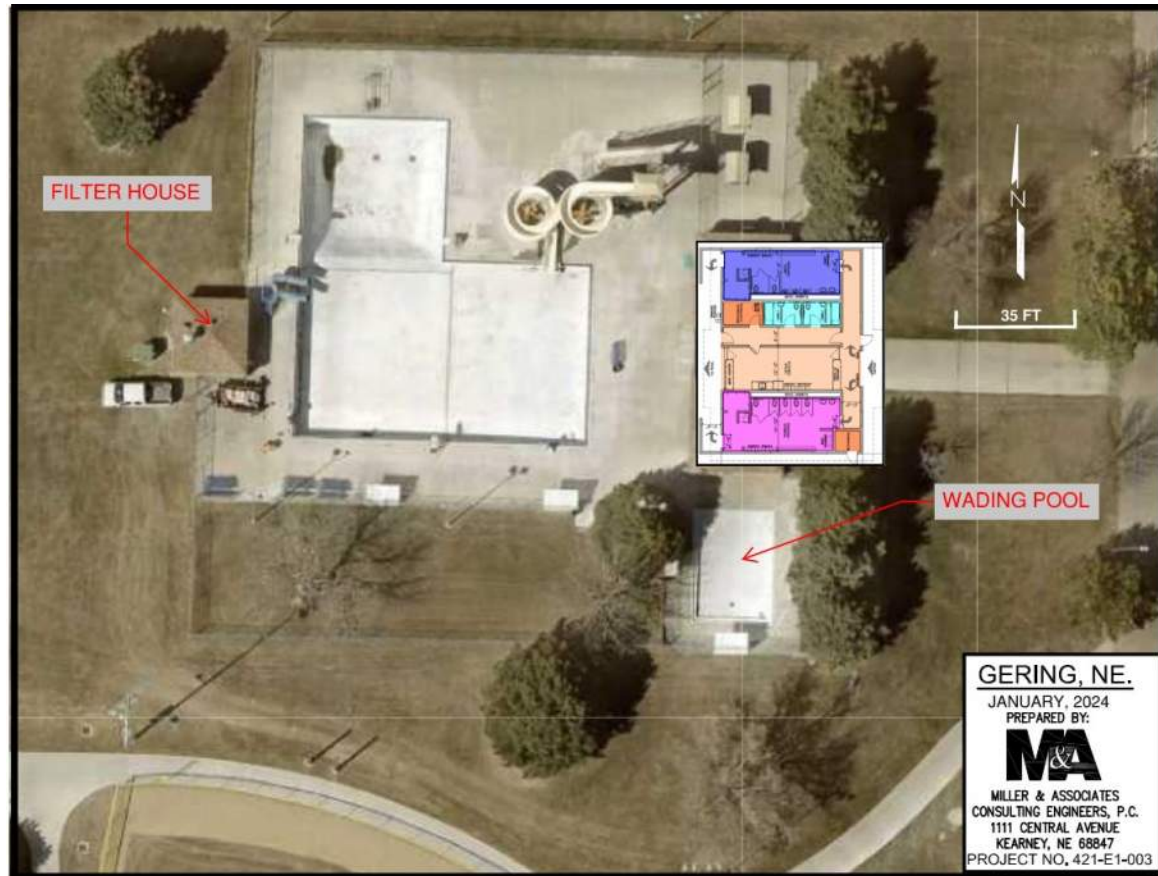
Option 3:

New Bathhouse, New Wading Pool, and Pool Improvements

- Revised Conceptual Bathhouse
- New Zero Entry Wading Pool
- Rehabilitate Swimming Pool
- Replace Pool Deck & Deck Equipment
- Replace DE Filter & Pump

****Will address all deficiencies except for the required recirculation rate.***

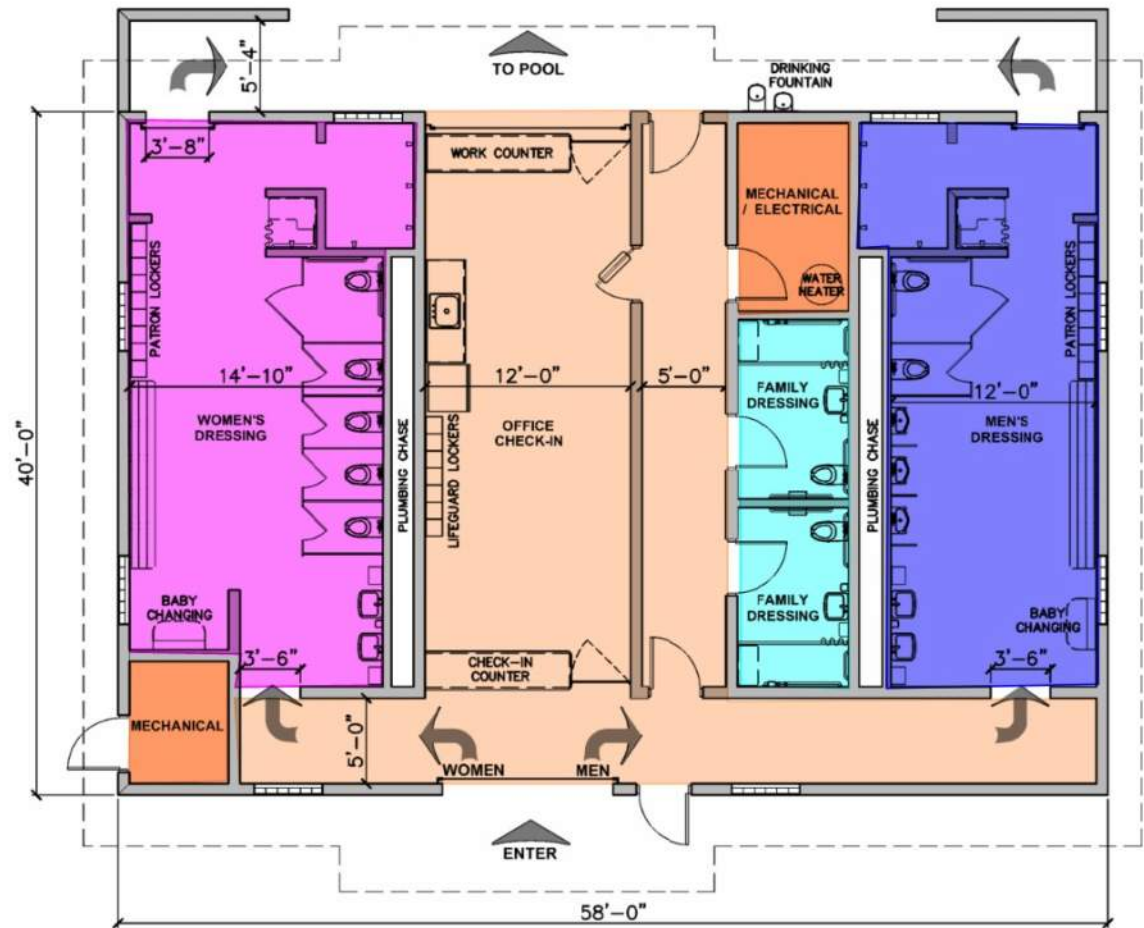
Option 3:

Revised
Conceptual
Bathhouse
(400 Bathing)

Revised Conceptual Bathhouse

Size: 2,320 ft²

Project Cost: \$4,035,380

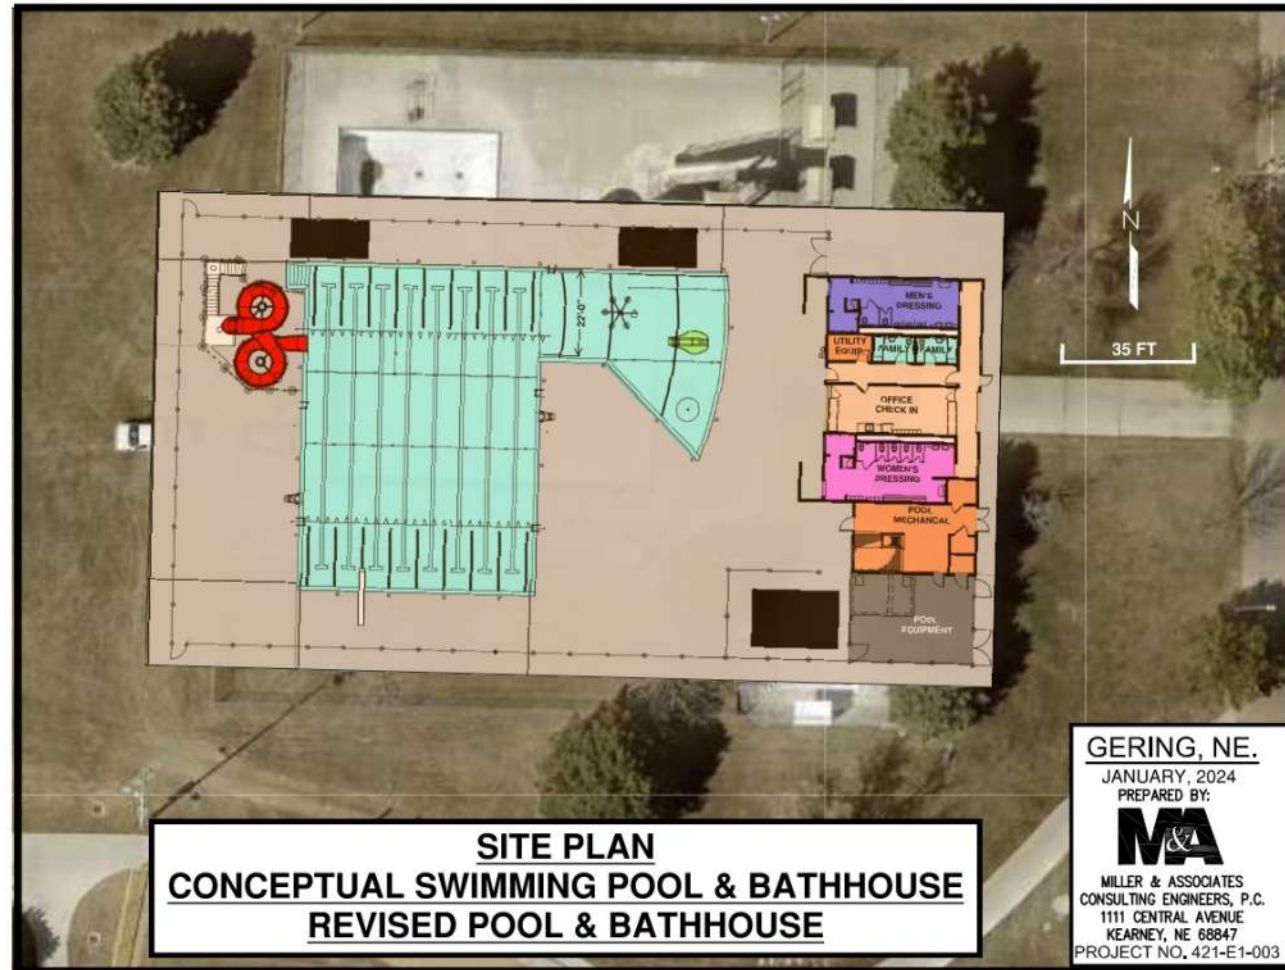
Option 4:

New Conceptual Bathhouse and Swimming Pool

Revised
Conceptual
Bathhouse

Revised
Conceptual
Swimming Pool

****Will Address All
Deficiencies***

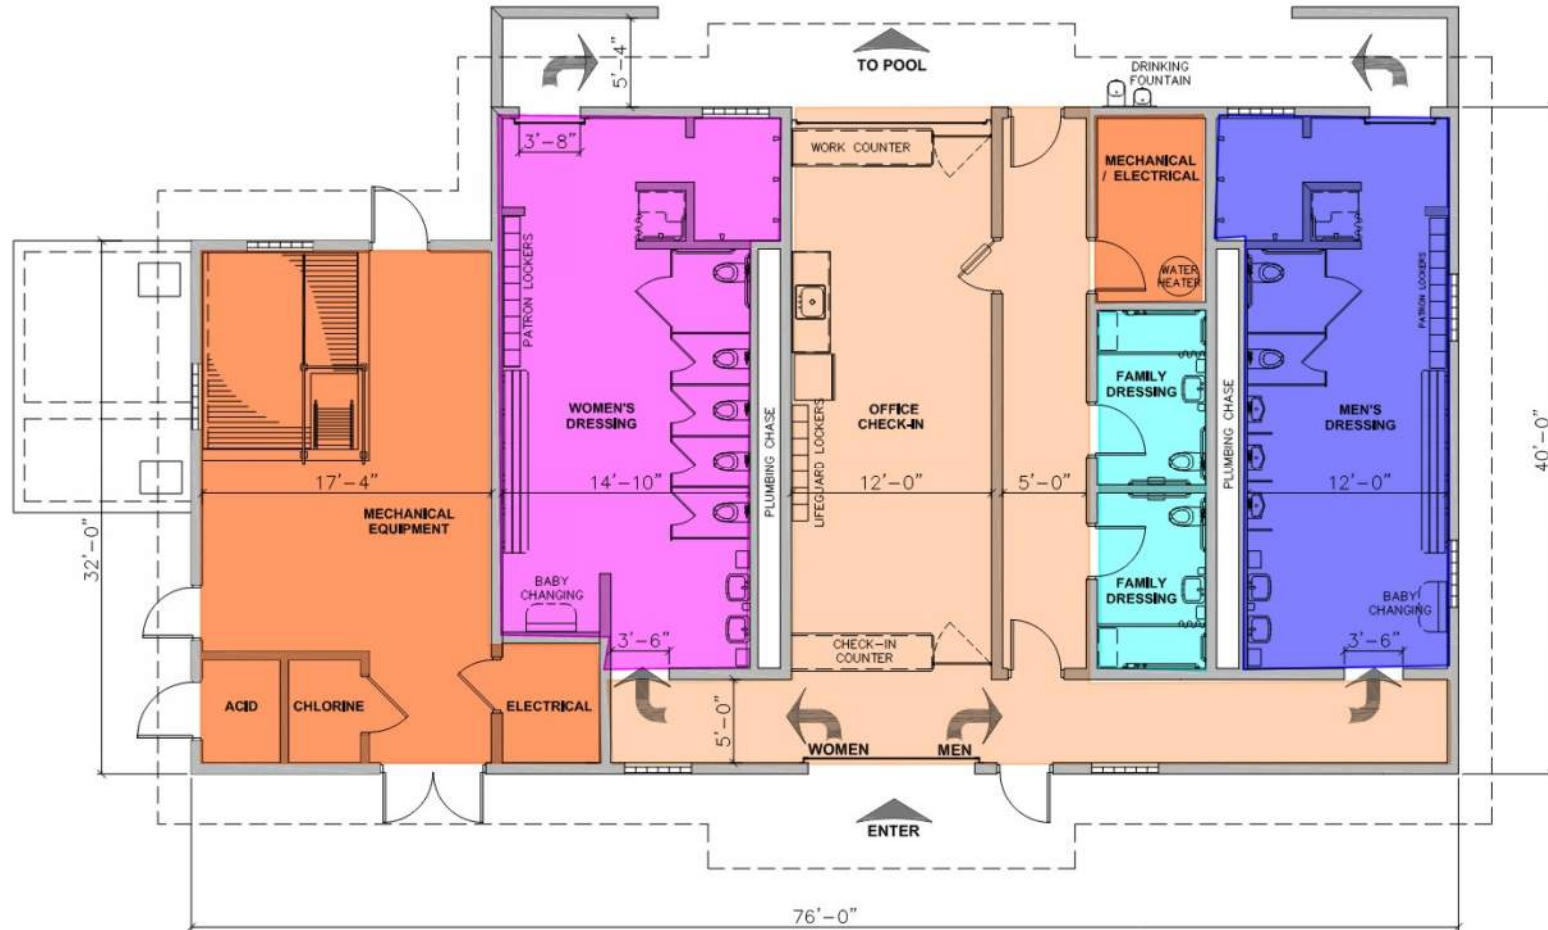
Option 4:

Revised
Conceptual
Bathhouse

Revised Conceptual Bathhouse
 -

Size: 2,896 ft²
-

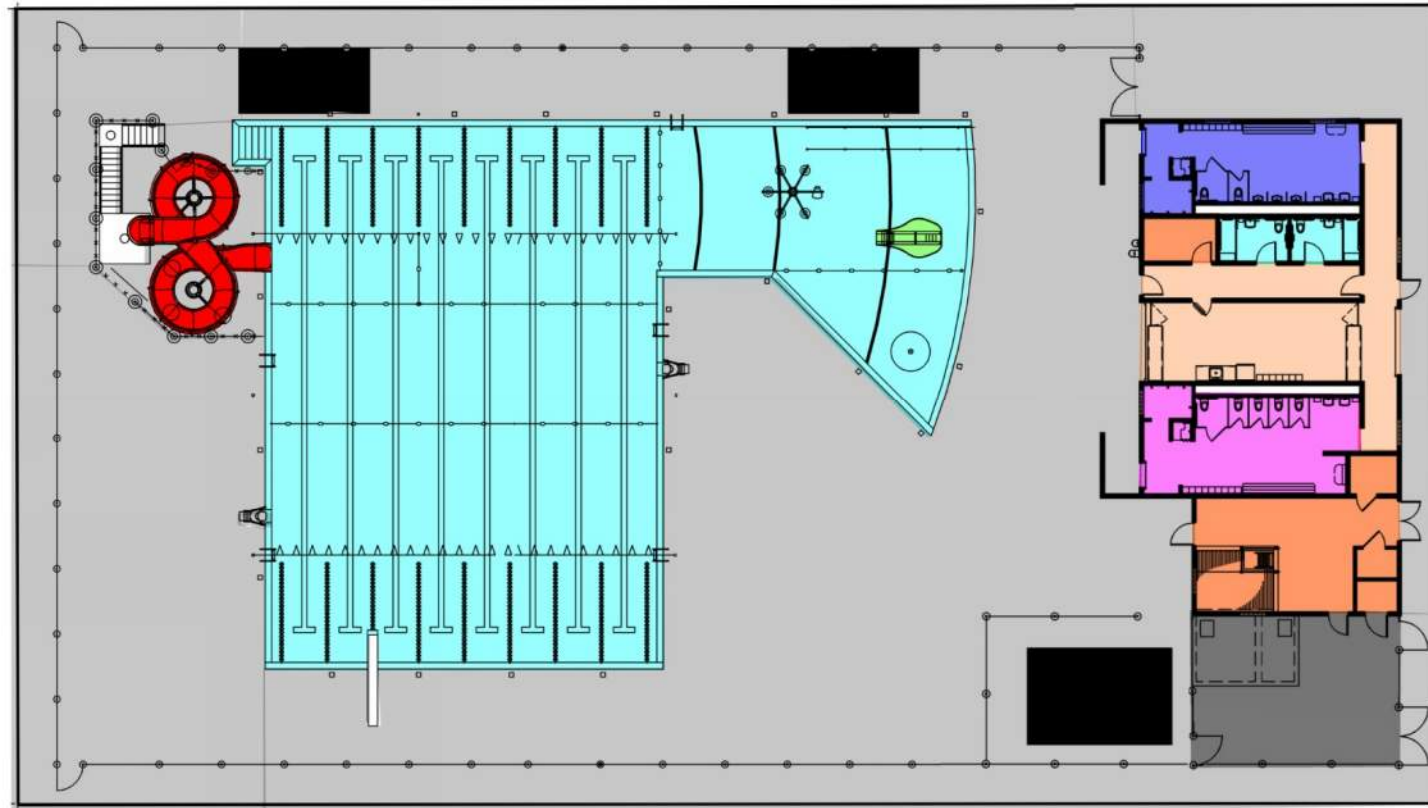
Option 4:

REVISED CONCEPTUAL SWIMMING POOL

- 8 lanes, 25 meters
- Zero entry to the swimming pool
- Play features in the zero-entry area
- 1-meter diving board
- Flume Slide

Revised Conceptual Swimming Pool
 -

Size: 6,270 ft²
-
